**Flood Control Project Maintenance
Levee Inspections**

Maintenance Issue Types Only, Levee Inspection Report By Mile - Spring 2019

Tehama County Flood Control and Water Conservation District

Waterway	Bank	Unit Miles	Inspection Start/End	Inspector
Unit No. 01 Deer Creek	Left	4.22	05/01/2019 05/01/2019	Makar Sokol

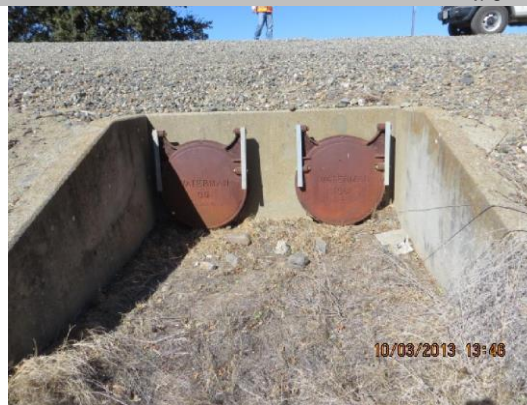
Photo 3 of 3 : UCIP_SP_2019_21766_36990.jpg

Flapgate on WS toe.

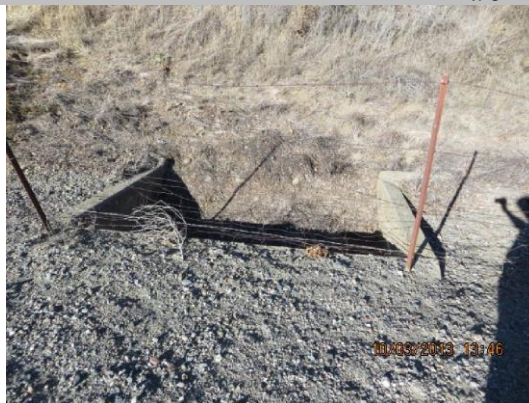
Photo 1 of 3 : UCIP_SP_2019_22828_38978.jpg

LM Start	1.99	Rating **	A/W	Issue No.	932
LM End	1.99	Issue Type +	Ma	Location *	
Category	Supplemental			GPS Latitude/Longitude	
				Start	End
Item	DWR UCIP LMA Responsibility			40.052729 °	40.052729 °
				-122.154673 °	-122.154673 °
DWR ID	20885				
Comment Code					
Inspector Comment					
FS_ID:22828 DS_ID:20885 EP_NO: N/A Repair Type: No Action Needed Crossing Status: Found UCIP Comments: FIELD_STRUCT_DESC: 2 of 2: 36-inch corrugated metal drainage pipe through the levee, 7.6 feet below the crown. Flap gate and concrete U-shaped headwall on the waterside (WS) end. Concrete U-shaped headwall on the landside (LS) end. [Additional Reference(s): DWR Levee Log, 1992. USACE Sacramento O&M Manual 510, April 1963, (HLM 2.01) Drawing No. 50-4-3622]. FS Date: 10/3/2013

Concrete headwall on LS toe.

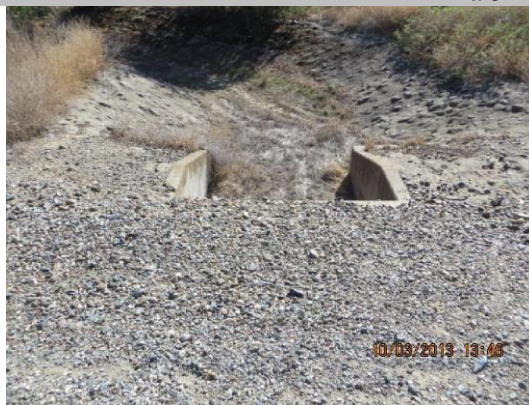
Photo 2 of 3 : UCIP_SP_2019_22828_38977.jpg

Concrete headwall and concrete channel on WS toe.

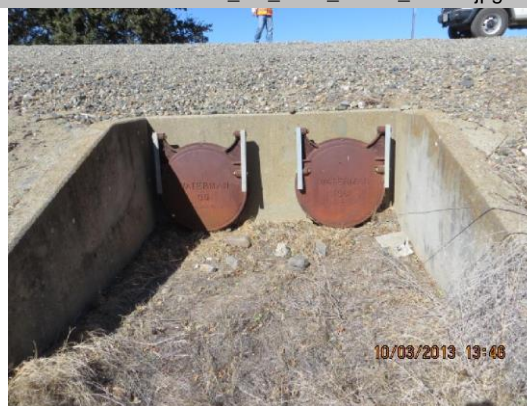
Photo 3 of 3 : UCIP_SP_2019_22828_38980.jpg

Flapgate on headwall at WS toe.

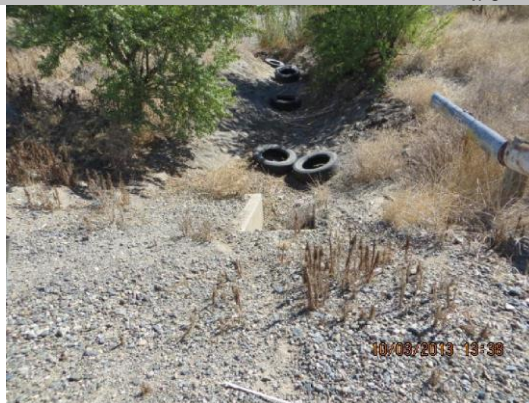
Photo 1 of 3 : UCIP_SP_2019_21763_36982.jpg

LM Start	2.21	Rating **	A/W	Issue No.	933
LM End	2.21	Issue Type +	Ma	Location *	
Category	Supplemental			GPS Latitude/Longitude	
				Start	End
Item	DWR UCIP LMA Responsibility			40.051985 °	40.051985 °
				-122.150737 °	-122.150737 °
DWR ID	20788				
Comment Code					
Inspector Comment					
FS_ID:21763 DS_ID:20788 EP_NO: N/A Repair Type: No Action Needed Crossing Status: Found UCIP Comments: FIELD_STRUCT_DESC: 24-inch corrugated metal drainage pipe through the levee, 5.9 feet below the crown. Flap gate and concrete U-shaped headwall on the waterside (WS) end. Concrete U-shaped headwall on the landside (LS) end. [Additional Reference(s): DWR Levee Log, 1992. USACE Sacramento O&M Manual 510, April 1963, (HLM 2.24) Drawing No. 50-4-3622]. FS Date: 10/3/2013

Concrete U-shaped headwall on WS slope.

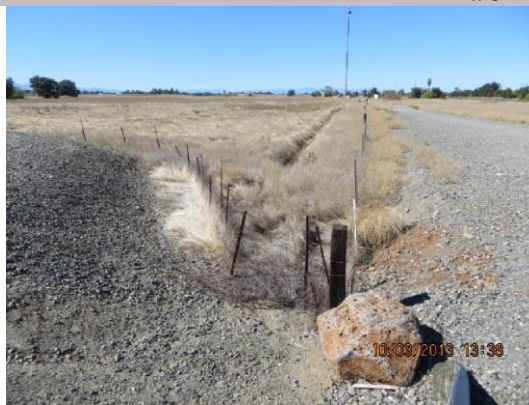
Photo 2 of 3 : UCIP_SP_2019_21763_36981.jpg

Inlet off LS toe in channel.

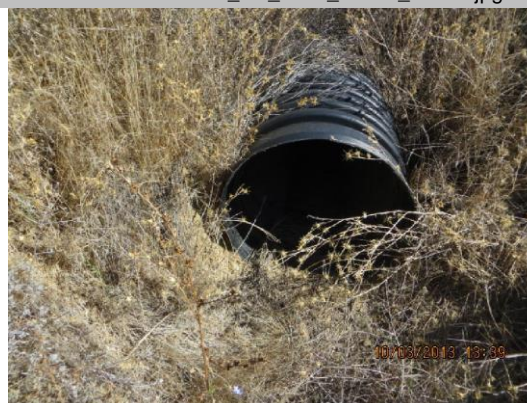
Photo 3 of 3 : UCIP_SP_2019_21763_36980.jpg

HDPE pipe inlet on LS toe.

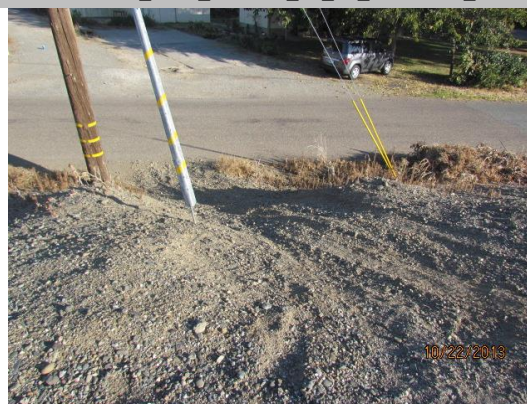
Photo 1 of 1 : SP_2019_NA0019_81_12_20190327_00007.jpg

LM Start	2.32	Rating **	M	Issue No.	12
LM End	2.32	Issue Type +	Ma	Location *	LS
Category	Earthen Levee			GPS Latitude/Longitude	
				Start	End
Item	Slope Stability			40.052443 °	40.052443 °
				-122.148863 °	-122.148863 °
DWR ID	DWR_NA0019_04_f_2013_12				
Comment Code					
S3 : Repair the levee slope damaged by vehicle traffic and prevent access where possible.					
Inspector Comment

View of the slope instability caused by vehicles along the landside slope.

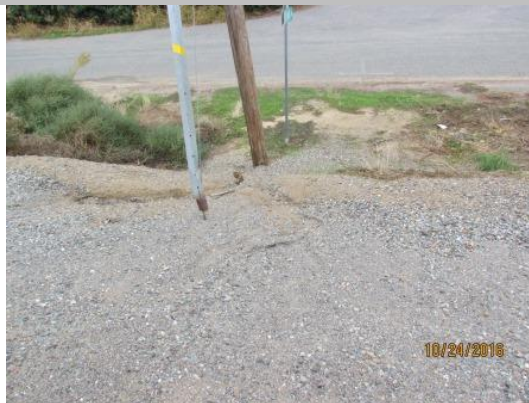
Photo 1 of 1 : SP_2019_NA0019_81_32_20190327_00019.jpg

LM Start	2.58	Rating **	M	Issue No.	32
LM End	2.58	Issue Type +	Ma	Location *	LS
Category	Earthen Levee			GPS Latitude/Longitude	
				Start	End
Item	Slope Stability			40.053767 °	40.053767 °
				-122.144719 °	-122.144719 °
DWR ID	DWR_NA0019_04_f_2016_32				
Comment Code					
S2 : Repair the levee slope damaged by foot traffic and prevent access where possible.					
Inspector Comment

View of the slope instability caused by vehicles along the landside slope.

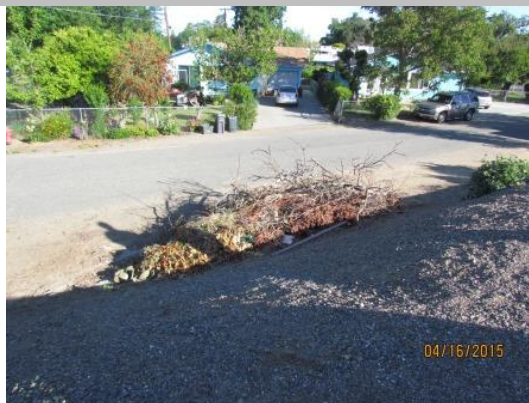
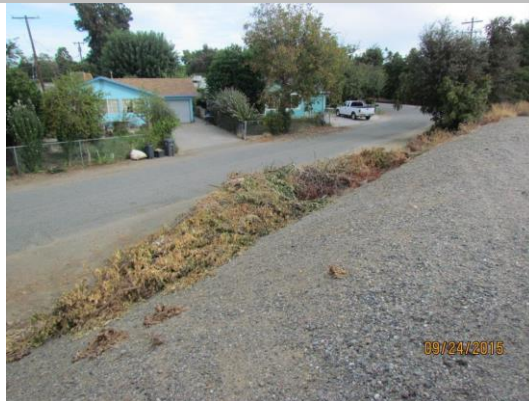
LM Start	2.63	Rating **	M	Issue No.	15
LM End	2.63	Issue Type +	Ma	Location *	LS
Category	Earthen Levee			GPS Latitude/Longitude	
				Start	End
Item	Encroachments			40.054337 °	40.054337 °
				-122.144235 °	-122.144235 °
DWR ID	DWR_NA0019_04_s_2015_15				
Comment Code					
PR : Prunings					
Inspector Comment					
Remove the prunings from the landside toe.

View of the prunings along the landside toe.

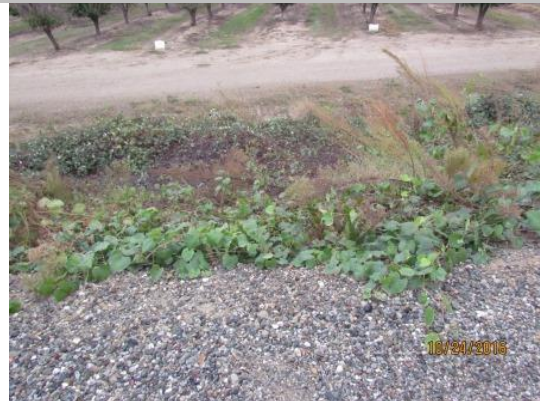
Photo 1 of 1 : SP_2019_NA0019_81_39_20190327_00021.jpg

LM Start	3.40	Rating **	M	Issue No.	39
LM End	3.44	Issue Type +	Ma	Location *	LS
Category	Earthen Levee			GPS Latitude/Longitude	
				Start	End
Item	Vegetation			40.056546 °	40.055906 °
				-122.133530 °	-122.133294 °
DWR ID	DWR_NA0019_04_f_2016_39				
Comment Code					
V2 : Remove the wild growth other than native grasses from the levee slopes.					
Inspector Comment

View of the blackberries along the landside slope blocking visibility and access.

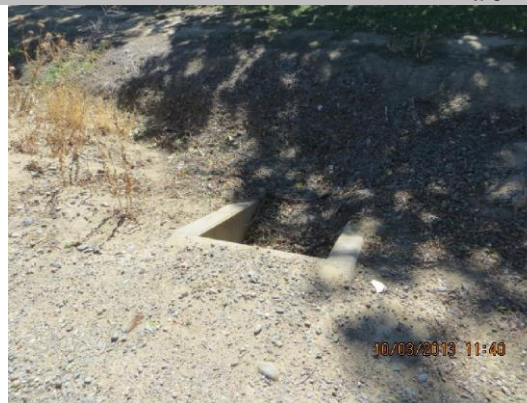
Photo 1 of 3 : UCIP_SP_2019_21744_36945.jpg

LM Start	0.11	Rating **	A/W	Issue No.	20
LM End	0.11	Issue Type +	Ma	Location *	
Category	Supplemental			GPS Latitude/Longitude	
				Start	End
Item	DWR UCIP LMA Responsibility			40.051702 °	40.051702 °
				-122.189922 °	-122.189922 °
DWR ID	20799				
Comment Code					
Inspector Comment					
FS_ID:21744 DS_ID:20799 EP_NO: N/A Repair Type: No Action Needed Crossing Status: Found UCIP Comments: FIELD_STRUCT_DESC: 24-inch corrugated metal drainage pipe through the levee, 5.4 feet below the crown. Flap gate on the waterside (WS) end. Concrete U-shaped headwalls on the WS and landside (LS) ends. [Additional Reference(s): DWR Levee Log, 1992. USACE Sacramento O&M Manual 510, April 1963, (HLM 0.11) Drawing No. 50-4-3622]. FS Date: 10/3/2013

Concrete headwall on LS toe.

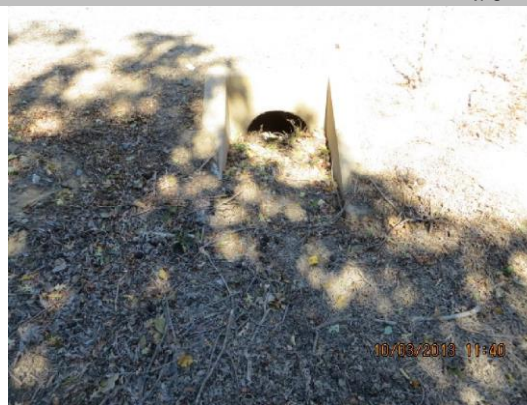
Photo 2 of 3 : UCIP_SP_2019_21744_36944.jpg

Concrete headwall on LS toe.

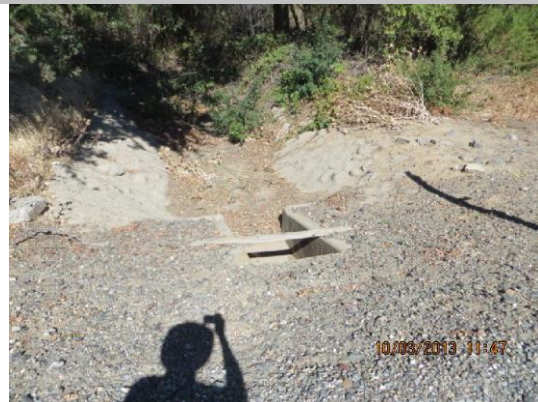
Photo 1 of 3 : UCIP_SP_2019_41124_36953.jpg

LM Start	0.50	Rating **	M	Issue No.	21
LM End	0.50	Issue Type +	Ma	Location *	
Category	Supplemental			GPS Latitude/Longitude	
				Start	End
Item	DWR UCIP LMA Responsibility			40.050585 °	40.050585 °
				-122.182972 °	-122.182972 °
DWR ID	20801				
Comment Code					
Inspector Comment					
FS_ID:41124 DS_ID:20801 EP_NO: N/A Repair Type: Non-Urgent Crossing Status: Found UCIP Comments: Debris inside pipe at WS toe needs to be removed as it may prevent proper operation of the flapgate. FIELD_STRUCT_DESC: 24-inch corrugated metal drainage pipe through the levee, 5.2 feet below the crown. Flap gate on the waterside (WS) end. Concrete U-shaped headwalls on the WS and landside (LS) ends. [Additional Reference(s): DWR Levee Log, 1992. USACE Sacramento O&M Manual 510, April 1963, (HLM 0.51) Drawing No. 50-4-3622]. FS Date: 10/3/2013

Concrete headwall on WS toe.

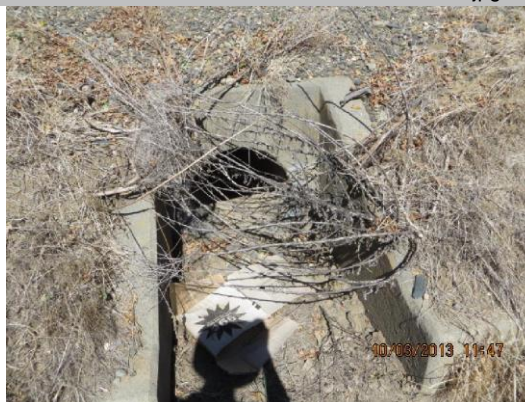
Photo 3 of 3 : UCIP_SP_2019_41124_36951.jpg

Concrete headwall at LS toe.

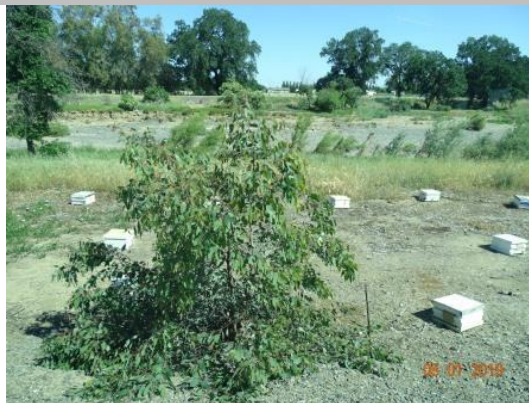
Photo 1 of 1 : SP_2019_NA0019_82_6_20190506_00019.jpg

LM Start	0.69	Rating **	M	Issue No.	6
LM End	0.69	Issue Type +	Ma	Location *	WS
Category	Earthen Levee			GPS Latitude/Longitude	
				Start	End
Item	Trim / Thin Trees			40.050287 °	40.050287 °
				-122.179464 °	-122.179464 °
DWR ID	DWR_NA0019_05_s_2019_6				
Comment Code					
T2 : Thin trees to allow visibility of the ground and room to flood fight.					
Inspector Comment					
Trees four inches in diameter or less at the chest height should be removed from the waterside toe.

View of a small tree at the waterside toe. Spring 2019.

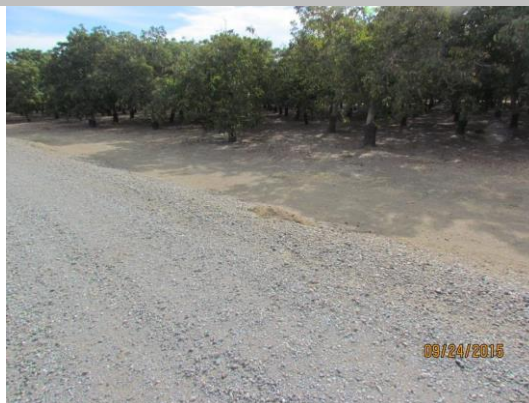
Photo 1 of 1 : SP_2019_NA0019_82_8_20190327_00003.jpg

LM Start	0.94	Rating **	M	Issue No.	8
LM End	1.05	Issue Type +	Ma	Location *	LS
Category	Earthen Levee			GPS Latitude/Longitude	
				Start	End
Item	Animal Control			40.051360 °	40.052361 °
				-122.175063 °	-122.173450 °
DWR ID	DWR_NA0019_05_f_2015_8				
Comment Code					
A1 : Exterminate rodents and backfill and compact or grout burrows.					
Inspector Comment

View of the rodent holes along the landside slope.

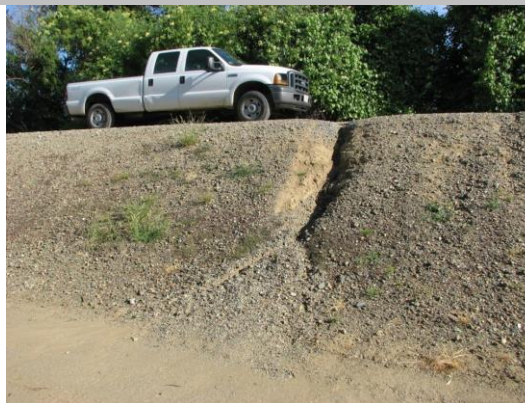
Photo 1 of 1 : SP_2019_NA0019_82_10_20190327_00004.jpg

LM Start	3.35	Rating **	U	Issue No.	10
LM End	3.35	Issue Type +	Ma	Location *	LS
Category	Earthen Levee			GPS Latitude/Longitude	
				Start	End
Item	Erosion / Bank Caving			40.056875 °	40.056875 °
				-122.135349 °	-122.135349 °
DWR ID	DWR_NA0019_05_s_2016_10				
Comment Code					
E2 : Schedule repair of erosion site prior to the next inspection.					
Inspector Comment					
Erosion rut runs down the landside slope from crown to toe.

View of the erosion along the landside slope.
